MI HOME BUYER SURVEY

HOME BUYER SURVEY REPORT

PROPERTY xxx
xxx
xxx

The format of this Mi HOME BUYER SURVEY REPORT is consistent with the guidance note requirements for a Survey Level 2 as defined by RICS Surveys of Residential Property 3rd edition May 2016

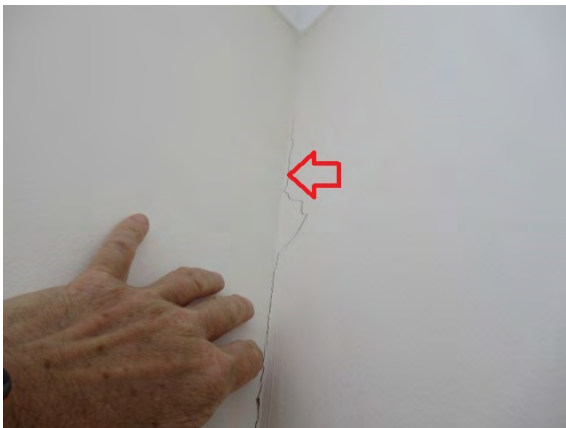
<p>Condition</p>	<p>No significant defects were noted during my inspection and the internal walls were found to be structurally sound.</p> <p>No evidence was seen of any cracking which might indicate that the property is subject to subsidence or unusual settlement.</p> <p>All moisture meter readings recorded around the property were found to be within a normal range indicating that, in those areas that could be accessed, it is not affected by rising or penetrating damp.</p> <p>Normal maintenance is required, including filling and redecorating cracks as necessary.</p>

<p>Cracking of the plaster to the front left corner of bedroom 3</p>

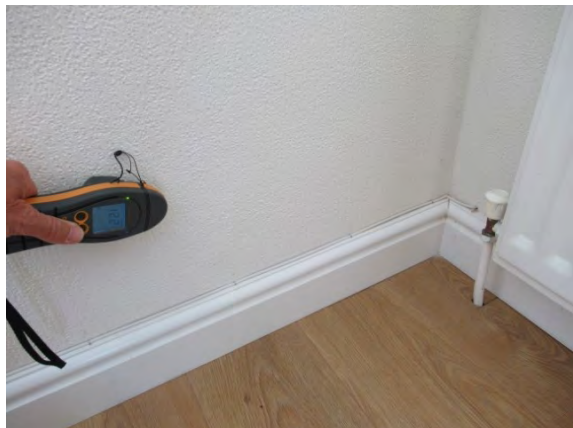
<p>Normal moisture reading on the front wall of the living room</p>

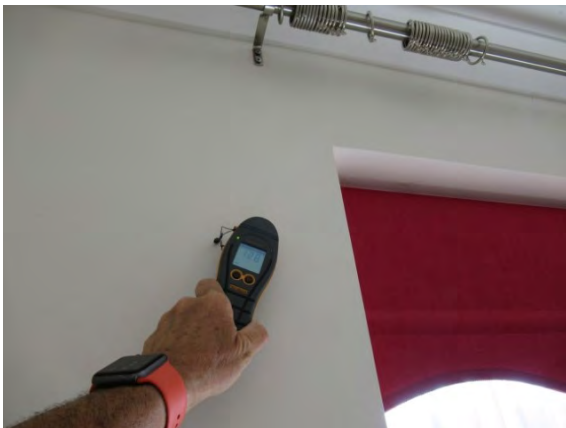
<p>Normal moisture reading on the wall of bedroom 1</p>

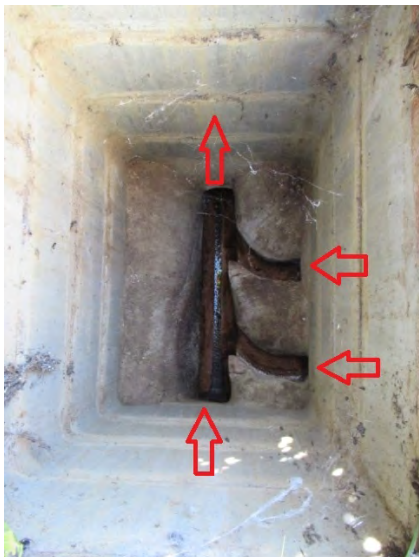
Condition	<p>Water was seen to run through the chamber with no blockages or undue levels of silt being apparent. The flow is from the house and forwards to the chamber at the front, whereupon it is directed to the left within a shared drain, presumably to a main sewer.</p> <p>Drains should be regularly inspected to ensure they remain free from blockages, tree root damage or other obstructions.</p>

<p>Inspection chamber in the front garden with the house to the right of the picture and the flow direction indicated</p>
