MI HOME BUYER SURVEY

HOME BUYER SURVEY REPORT

PROPERTY xxx
xxx
xxx

The format of this Mi HOME BUYER SURVEY REPORT is consistent with the guidance note requirements for a Survey Level 2 as defined by RICS Surveys of Residential Property 3rd edition May 2016

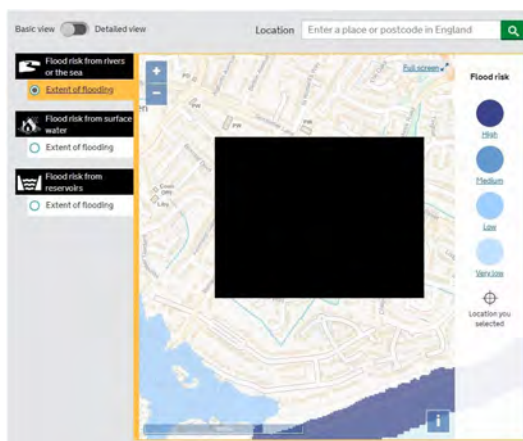
Flood risk low

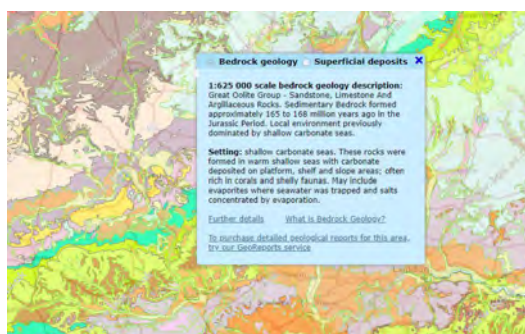
Bedrock

The property is located in an area where the ground is based on London clay.

No evidence was seen of any cracking, or other disturbance, which might be linked to seasonal ground movement.

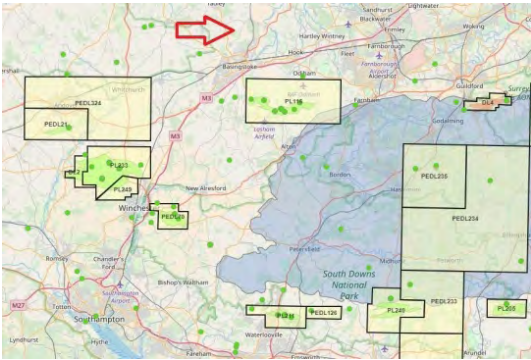
<p>Outside of OGA licence area</p>
Landfill	<p>There is no evidence that the property is located on or immediately adjacent to a former landfill site.</p>
Invasive Species	<p>Information available online suggests that there have been no reported instances of invasive plant species identified immediately adjacent to the property, though some have been reported within the general locality. However, such information is quite limited in its availability and scope and should not be relied upon as proof that no invasive plant species are present in, or around, the property.</p> <p>Invasive species include Japanese Knotweed (<i>Fallopia japonica</i>), Himalayan Balsam (<i>Impatiens glandulifera</i>) and Giant Hogweed (<i>Heracleum mantegazzianum</i>).</p> <p>Although no evidence of the presence of invasive plant species, such as Japanese Knotweed, was seen during the course of the survey, it can often be difficult to identify, especially where the gardens have been recently cut back or are overgrown.</p>

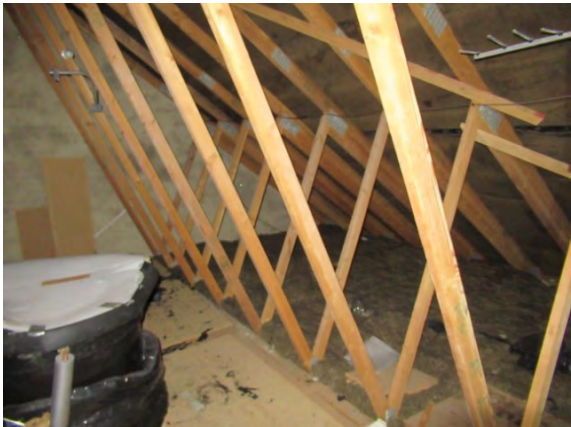
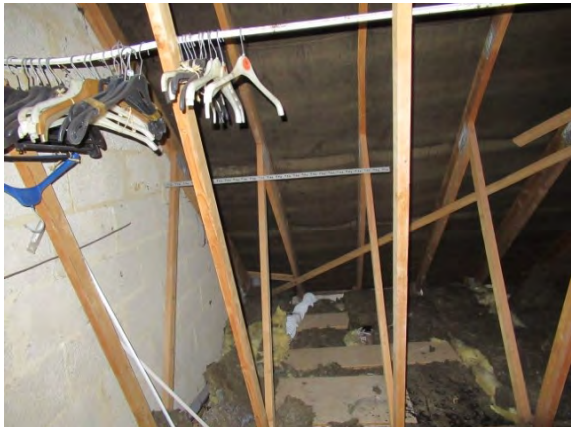
<p>Condition</p>	<p>No significant defects were noted during my inspection and the roof was found to be structurally sound.</p> <p>No evidence was seen of any unusual movement or stress of the supporting timbers within the roof, and there have been no obvious significant alterations to the structure which might have resulted in it becoming substantially weakened.</p> <p>Between the outer tile covering and the inner timbers is an underlining, sometimes called "sarking". It is present to provide an additional weather-proofing layer to moisture, snow and rain etc. that may be blown past the outer covering. In older properties it may not be present at all. Typically, in the 1920's the sarking is of timber planks. Later properties often have a layer of bituminised felt, while in modern properties a breathable membrane, such as Tyvek, is normally used. In this case the sarking is of bitumen felt. It was found to be in a mostly undamaged condition and is considered to be suitable for its purpose.</p> <p>Other than in those areas which have been boarded, the roof space is laid with approximately 200mm of wool type insulation at joist level. This is close to the current recommendation of 270mm for maximum energy efficiency. It does, however, limit movement and storage within the roof space as any supporting joists are concealed.</p> <p>High moisture levels within roof spaces are responsible for the promotion of the development of timber defects such as rot and infestations by wood boring insects (commonly known as woodworm). Wood moisture content readings taken were found to be well within normal limits and below the levels normally required for this type of defect.</p> <p>Care should be taken when moving around, or storing heavy objects, in the roof space. The spaces between the floor joists will not support a person's weight, or that of large boxes etc. Where heavy items are to be stored it is important to distribute the weight evenly using fixed boards. Additional structural support may be required if you plan to store large quantities of heavy items in the roof space.</p>

<p>Looking towards the right</p>
	<p>Looking towards the left rear</p>

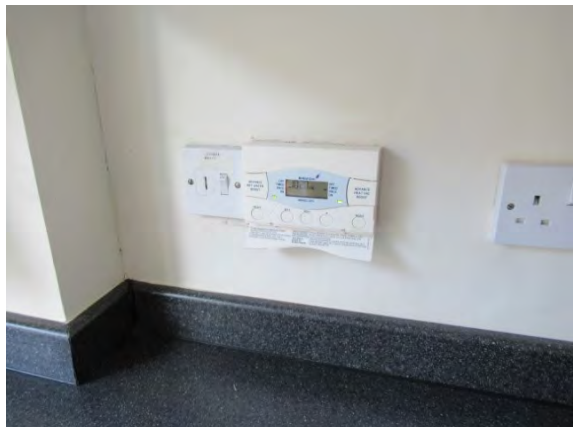
Condition	<p>The boiler is believed to be approximately 5 years old and, therefore, around one third of the way through its normal expected service life. Under normal circumstances a modern boiler will last for 15-20 years before requiring replacement.</p> <p>No evidence was seen to suggest that an inhibitor has been added to the heating system recently to prevent a build-up of sludge in the pipework and radiators, and it is therefore recommended that the system be flushed through and an inhibitor added.</p> <p>Gas Safe recommends that all gas appliances and boilers are inspected and serviced according to manufacturer's guidance, but at least once a year. A gas installation can look to be in a safe condition, but serious defects may be hidden, some of which can kill. It is therefore considered to be essential that you commission an inspection of the gas/heating installation prior to purchase of the property, unless you are provided with verifiable evidence that such an inspection has recently been carried out by a competent person. You can get more information, or find a Gas Safe registered engineer https://www.gassaferegister.co.uk/find-an-engineer/</p>

<p>Boiler</p> <p>Programmer</p>
